CALIFORNIA INSTITUTE OF TECHNOLOGY

EARTHQUAKE ENGINEERING RESEARCH LABORATORY

STATIC AND DYNAMIC TESTS OF A FULL-  
SCALE STEEL-FRAME STRUCTURE

August 1965

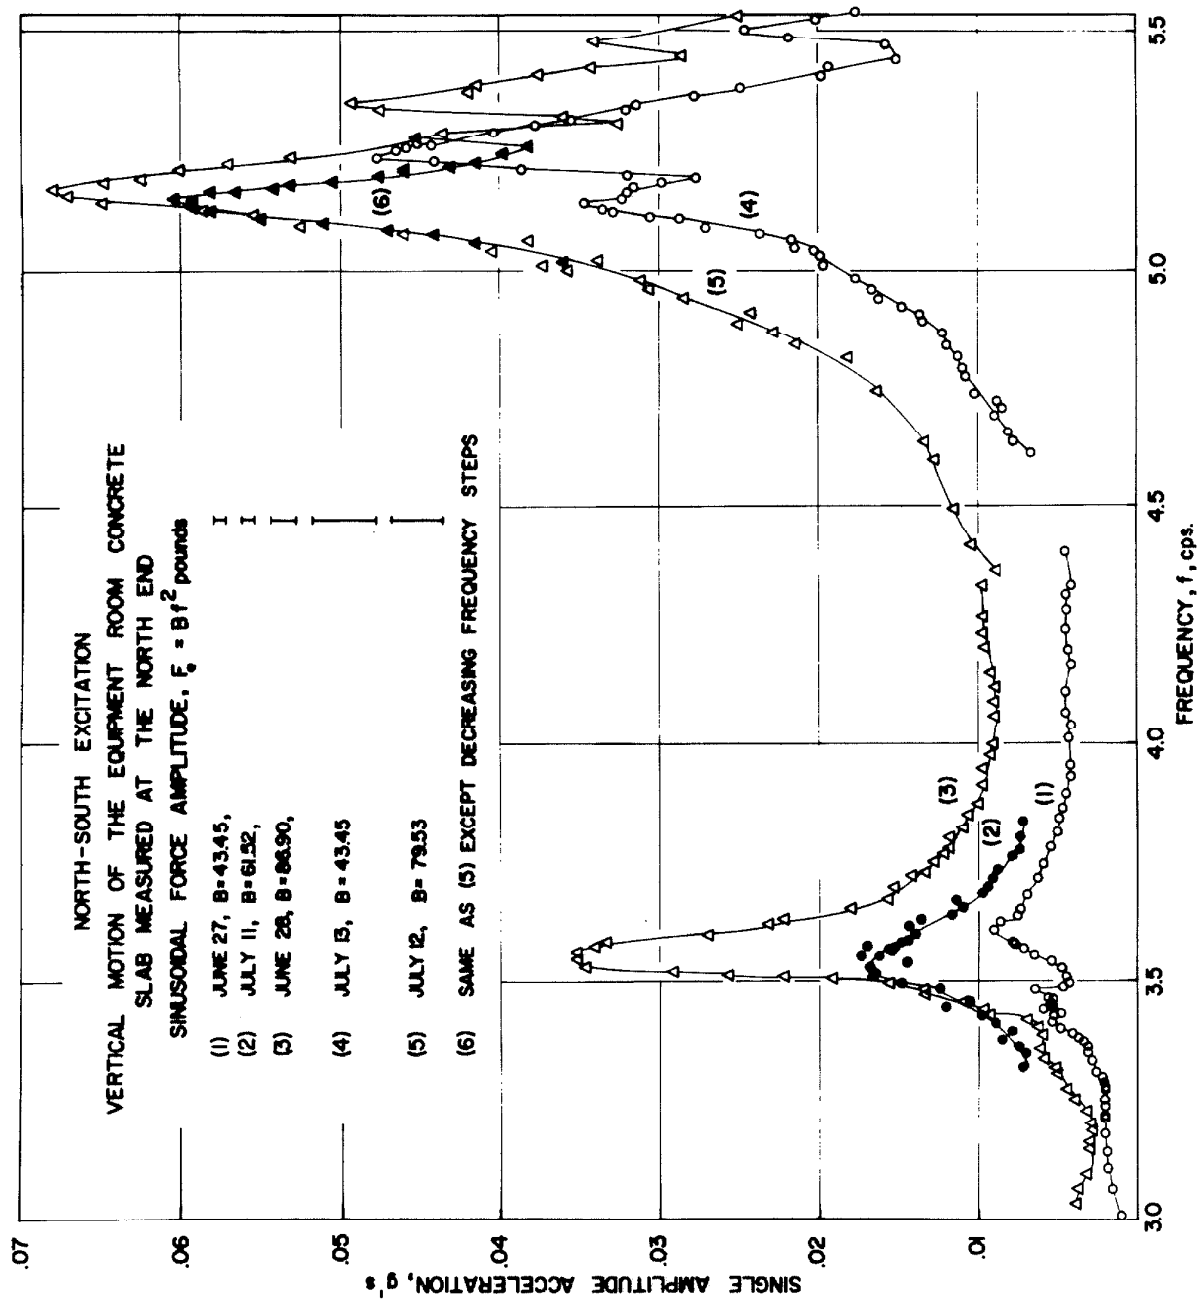
Fig. 21. Frequency response of gymnasium.

Figures 20 and 21 show the frequency response of the gymnasium to excitation in the North-South direction. It should be noted that the response associated with lower natural frequency is a combination of horizontal and vertical motion and that the higher natural frequency mode is predominantly vertical motion at the ends of the equipment room. The vertical motion at the south end was 180 degrees out of phase with the vertical motion at the north end in all tests. The damping calculated by the band width at the half power point of curve (4), Fig. 20, is 1.03 per cent of critical. Figure 22 gives the horizontal response in the East-West direction and Fig. 23 gives both vertical and horizontal response in the East-West direction. The vertical motion at the East and West positions also were 180 degrees out of phase for all tests. The damping calculated by the band width at the half power point of curves (3), Fig. 22, is 1.32 per cent

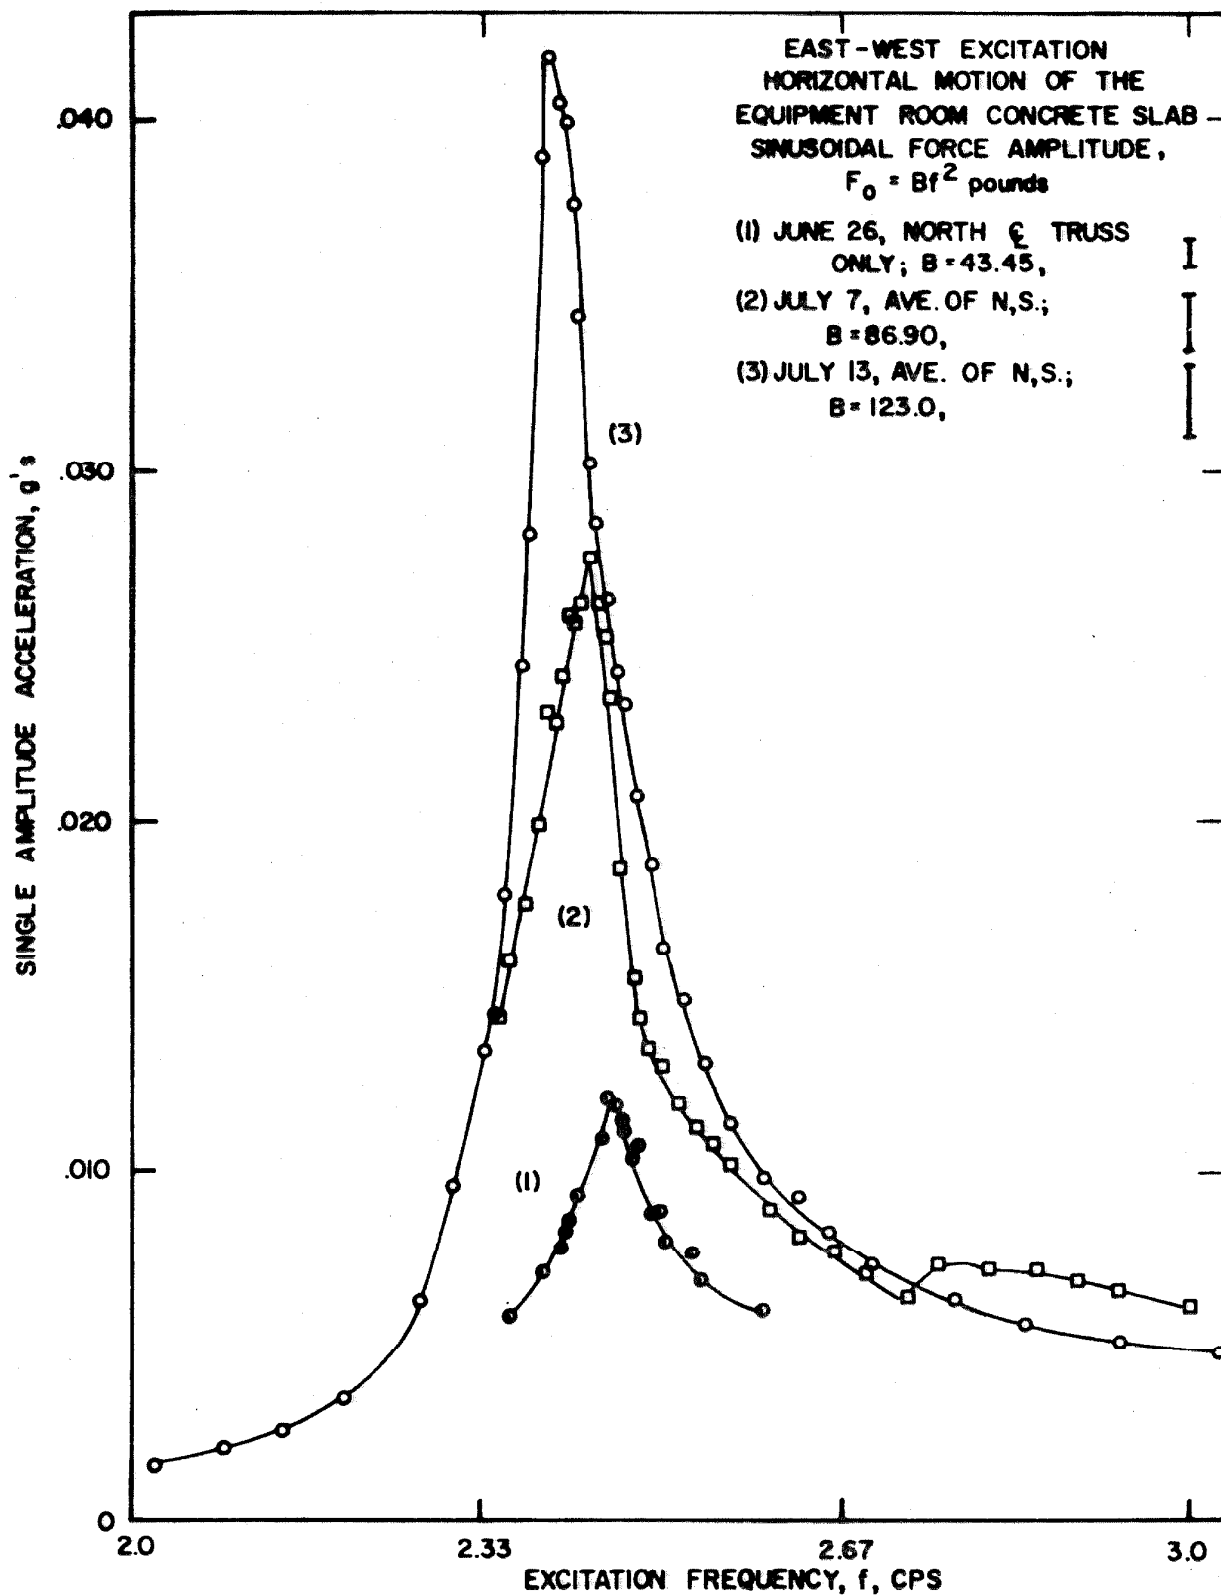
Fig. 22. Frequency response of gymnasium.

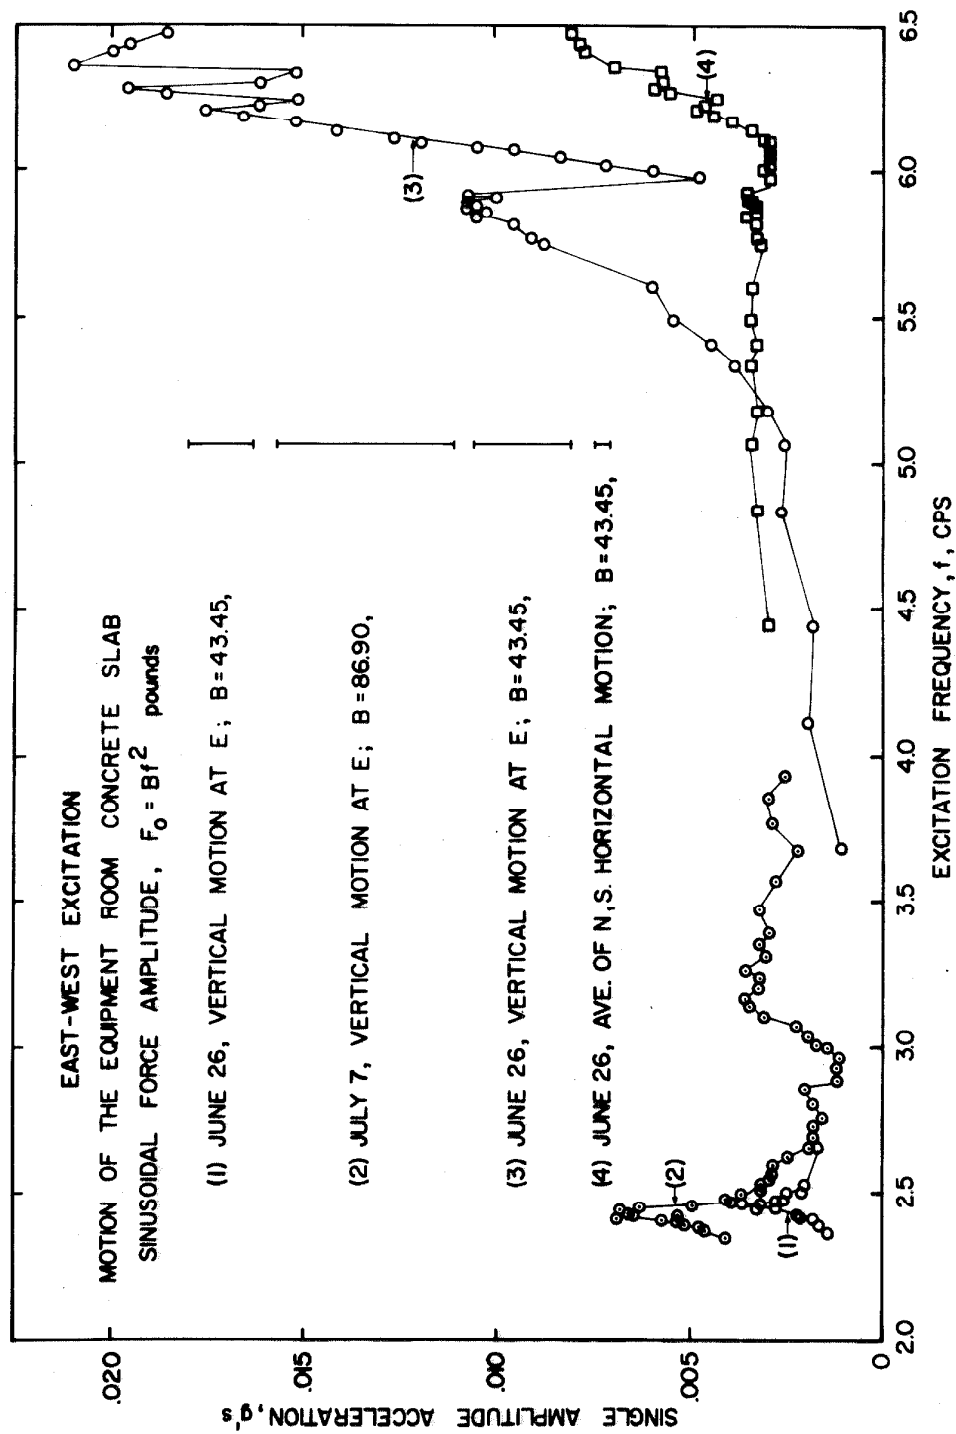
Fig. 23. Frequency response of gymnasium.

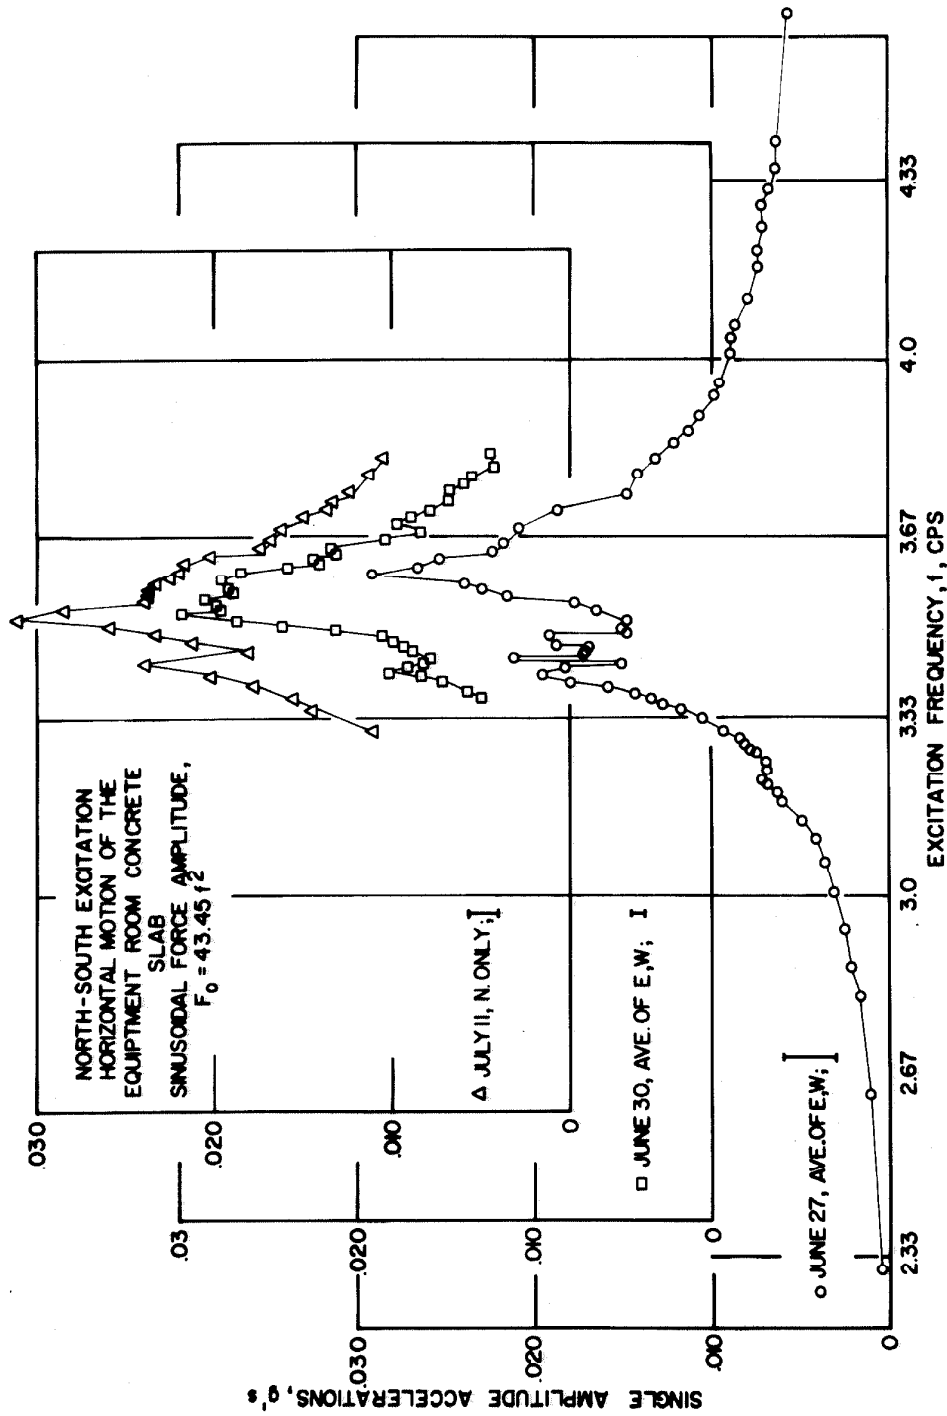
Fig. 24. Frequency response of gymnasium.

of critical. Figure 24 compares the response curves at the same force levels at various days throughout the testing sequence. It should be noted that weight of the structure did not change appreciably from 25 June until the dynamic studies were completed. The material to be included in the weight of the structure for the dynamic tests are: the steel of the structural system, three fans located at the lower level of the equipment room, the aluminum access stairway to the equipment room, the roof insulation stored in bundles, the sheet rock for the partition walls in the equipment room, and the lathing frame for the parapet wall.

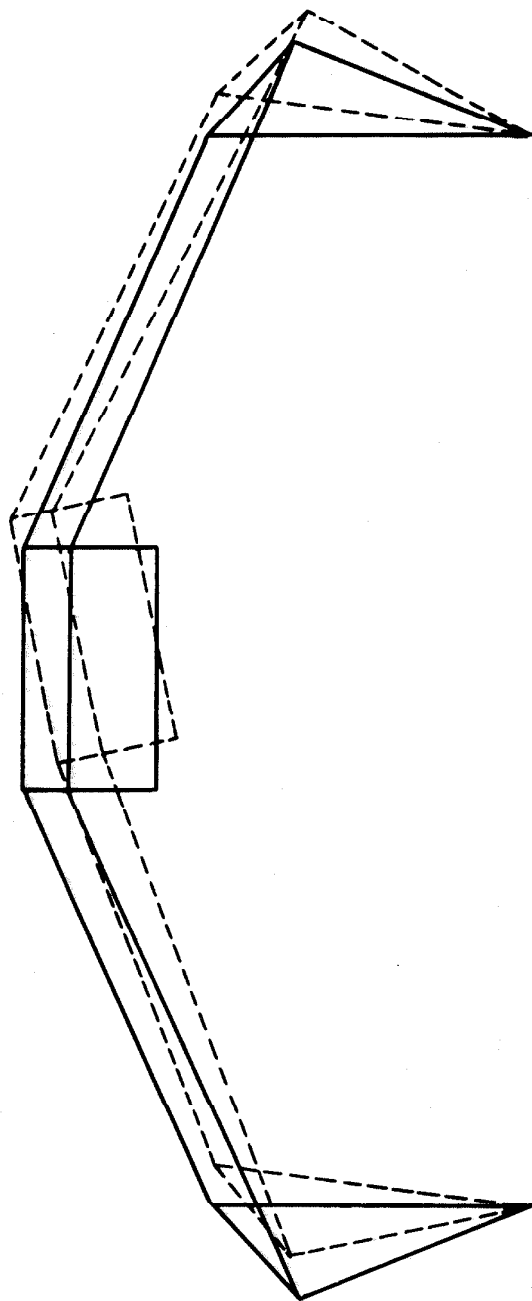
Fig. 25. Basic mode shape of structure.

The basic mode shape for the structure in the North-South and East-West directions is given in Fig. 25. Only the proportion of the vertical and horizontal components change for the various natural frequencies. The steel stairway was supported on small metal tubes at the bottom during the dynamic studies to prevent a horizontal force existing at this position. However, the nonsymmetry of the stairway relative to the structure was expected to cause a nonsymmetrical response of the structure. This was observed by comparing the response of the N and S vertical accelerations.

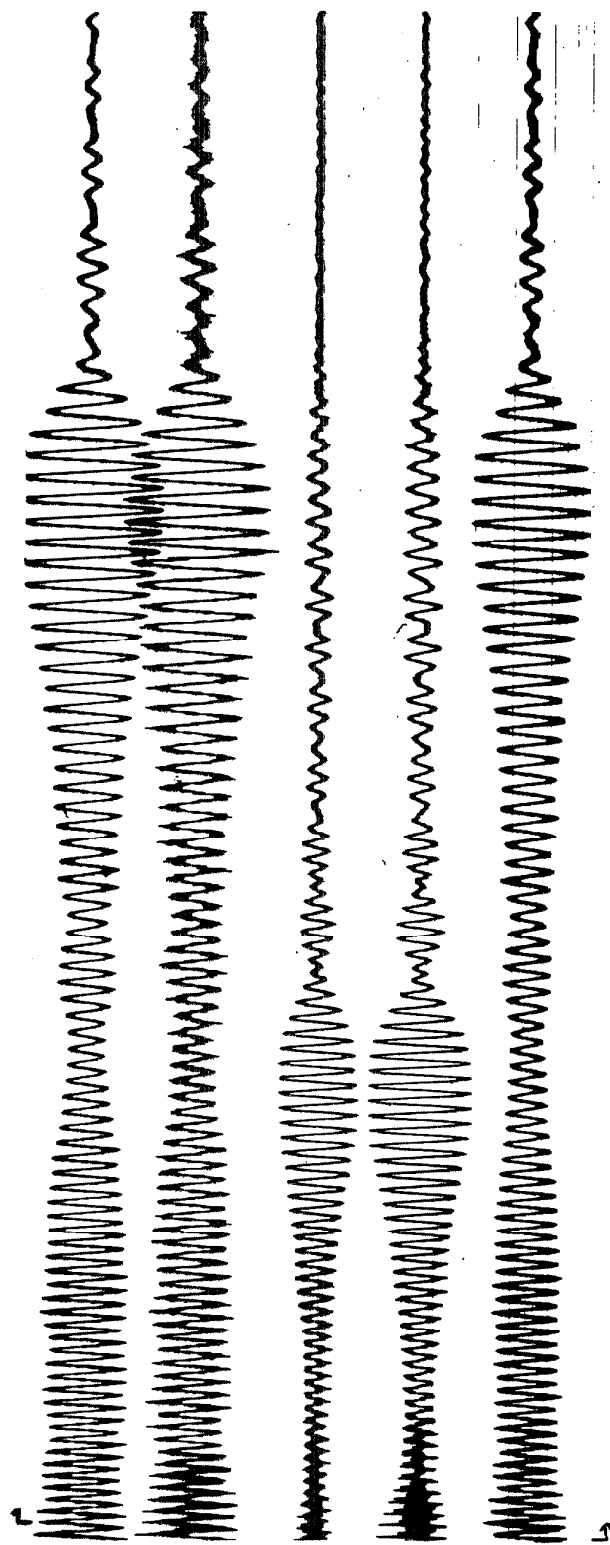
Fig. 26. Response to decreasing frequency.

Figure 26 shows the oscillogram of a test in which the frequency was constantly decreased from 7 cps to 0 cps with excitation in the

the North-South direction and  $B = 43.45$  . The data channels from left to right are: W horizontal, E horizontal, S vertical, N vertical, and North Truss horizontal. Note the beats and the differences between horizontal and vertical accelerations at various excitation frequencies.
